# DISHMILL BROOK WATERSHED – STORMWATER MASTER PLAN

## EAST BURKE, VERMONT

### FINAL REPORT

March 25, 2015

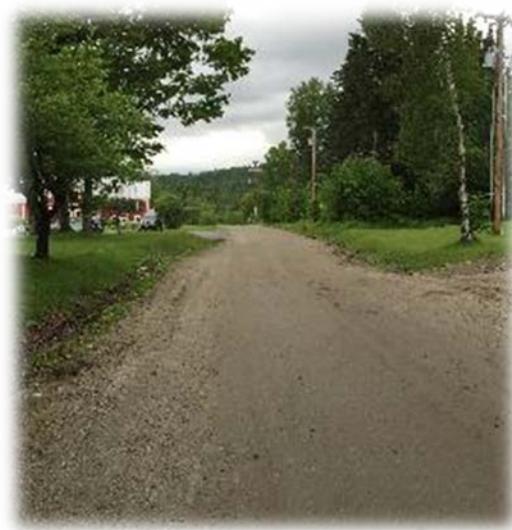
Road erosion assessment site DMB1 near Burke Mountain Academy on Alpine Lane.
